Service Bulletin Mazda North American Operations

Subject: Bulletin No: 02-004/13

STEERING WHEEL OFF CENTER WITHOUT DRIFT OR PULL

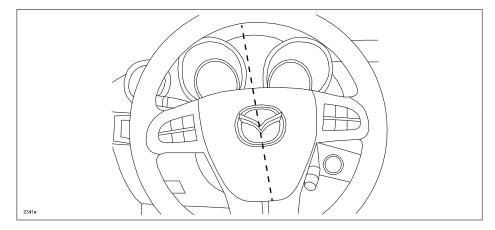
Some customers may complain that the steering wheel is off center more than 3° even when driving straight on a flat road.

Customers having this concern should have their vehicle repaired using the following repair procedure.

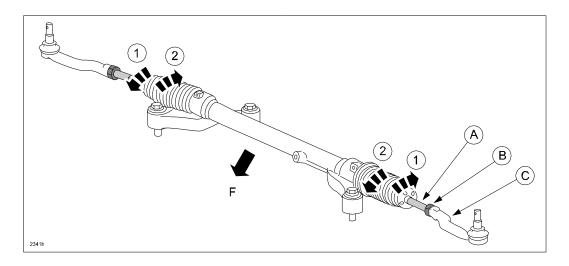
- A: Tie-rod B: Lock nut
- C: Tie-rod end
- F: Front of vehicle
- 1: Turn in this direction to loosen the tie-rod from the tie-rod end and increase the length.
- 2: Turn in this direction to tighten the tie rod towards the tie-rod end and decrease the length.

3. Rotate the tie-rod to adjust the steering wheel center. Refer to the following charts for rotating direction.

NOTE: Rotate both sides of the tie-rod by the same amount.
